**FORT SMITH HISTORIC DISTRICT COMMISSION
REGULAR MEETING
APRIL 4, 2024, 5:30 P.M.
DARBY COMMUNITY CENTER, 220 NORTH 7TH STREET**

Alternate Name: McCartney House</p> <p>Construction Date: c. 1905</p> <p>Address: 703 North 6th Street</p> <ul style="list-style-type: none">• Replace shingles on roof | <p>Owner: Gregg and Anne Marie Lodes</p> <p>Style Influence: Primary – Colonial Revival
Secondary – Classical Revival</p> <p>Significance: (1) Very Significant</p> |

Construction Date: c. 1891
Address: 715 North 6th Street</p> <ul style="list-style-type: none">• Replace siding and paint exterior of home | <p>Owner: Tedd and Emily Lodes</p> <p>Style Influence: Queen Anne/Eastlake</p> <p>Significance: (1) Very Significant</p> |

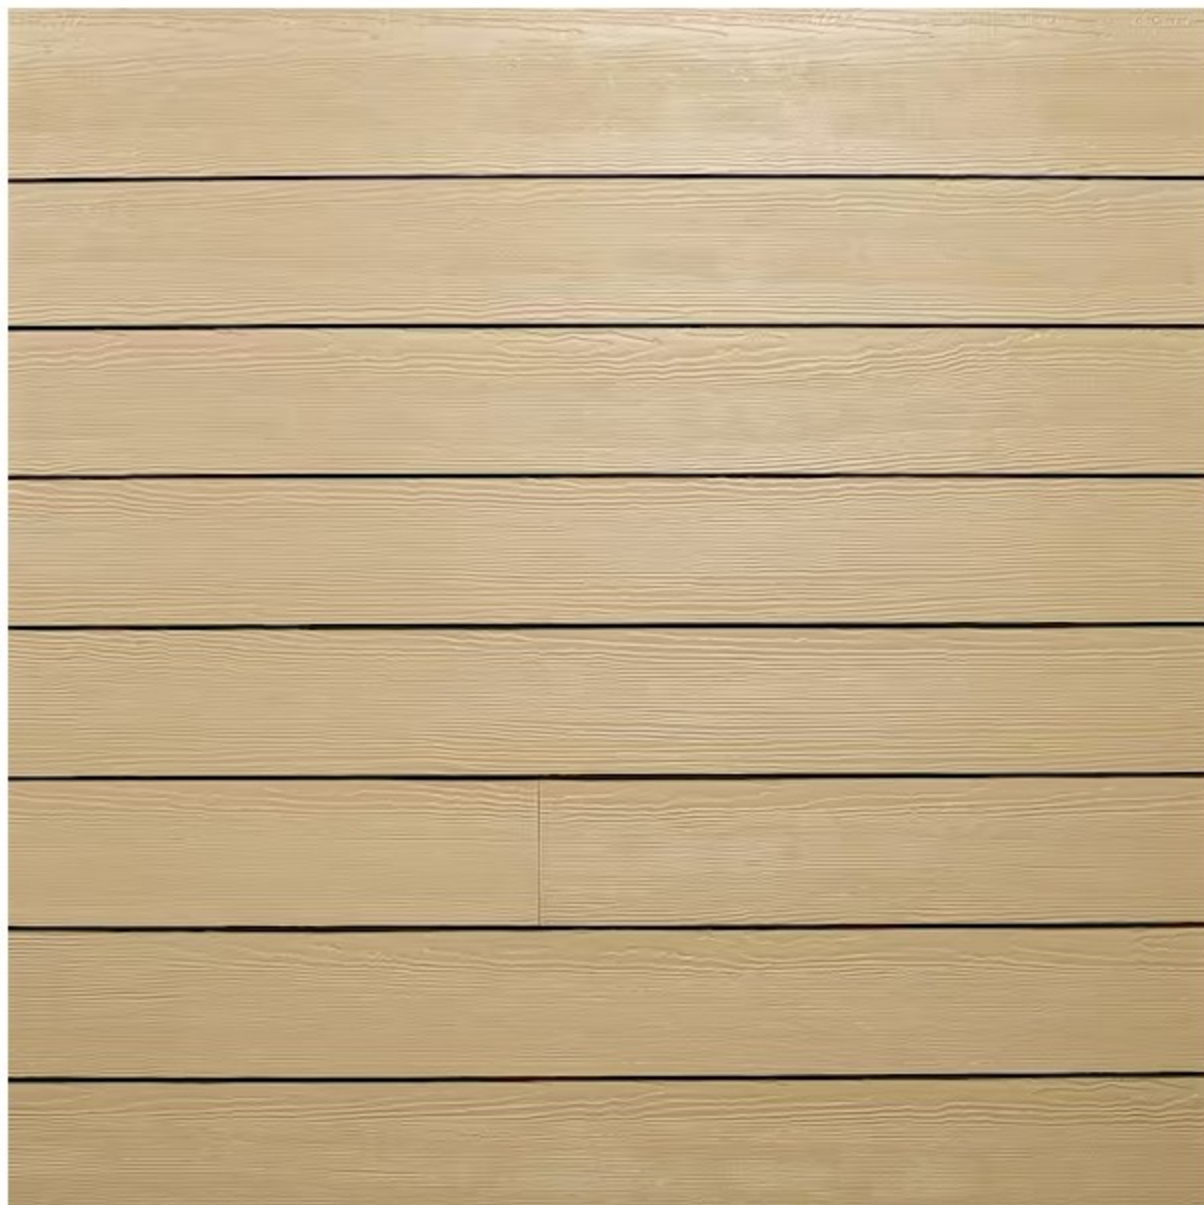
Hardie Plank HZ10 8.25 in. x 144 in. Primed Cedarmill Fiber Cement Lap Siding

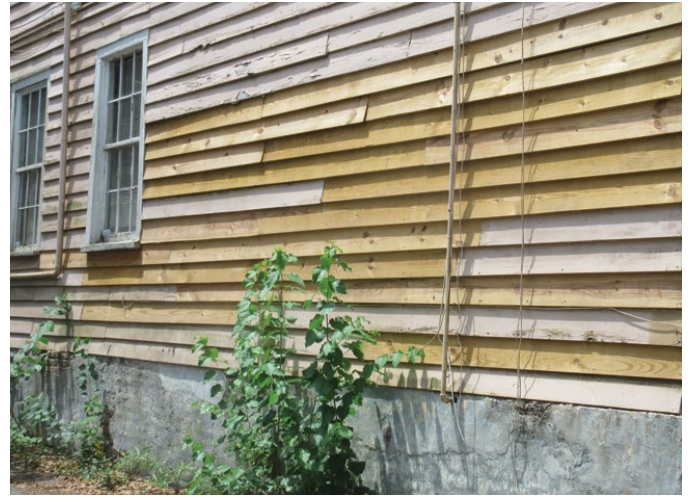
Figure 3: Incremental repair is best done using in-kind material to minimize differences in the performance characteristics that could negatively affect the overall assembly. Photo: NPS.

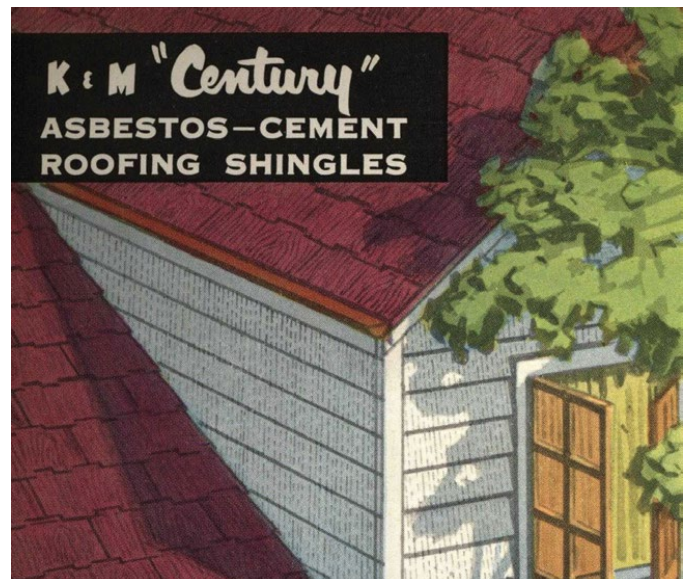
Figure 4. While occasionally used to imitate other materials such as wood or slate shingle, many asbestos shingles and siding materials had their own distinct shape and profile. No longer manufactured today, alternative materials must be found to replace these materials when they are distinctive features on a historic structure. Drawing: Association for Preservation Technology, Building Technology Heritage Library.

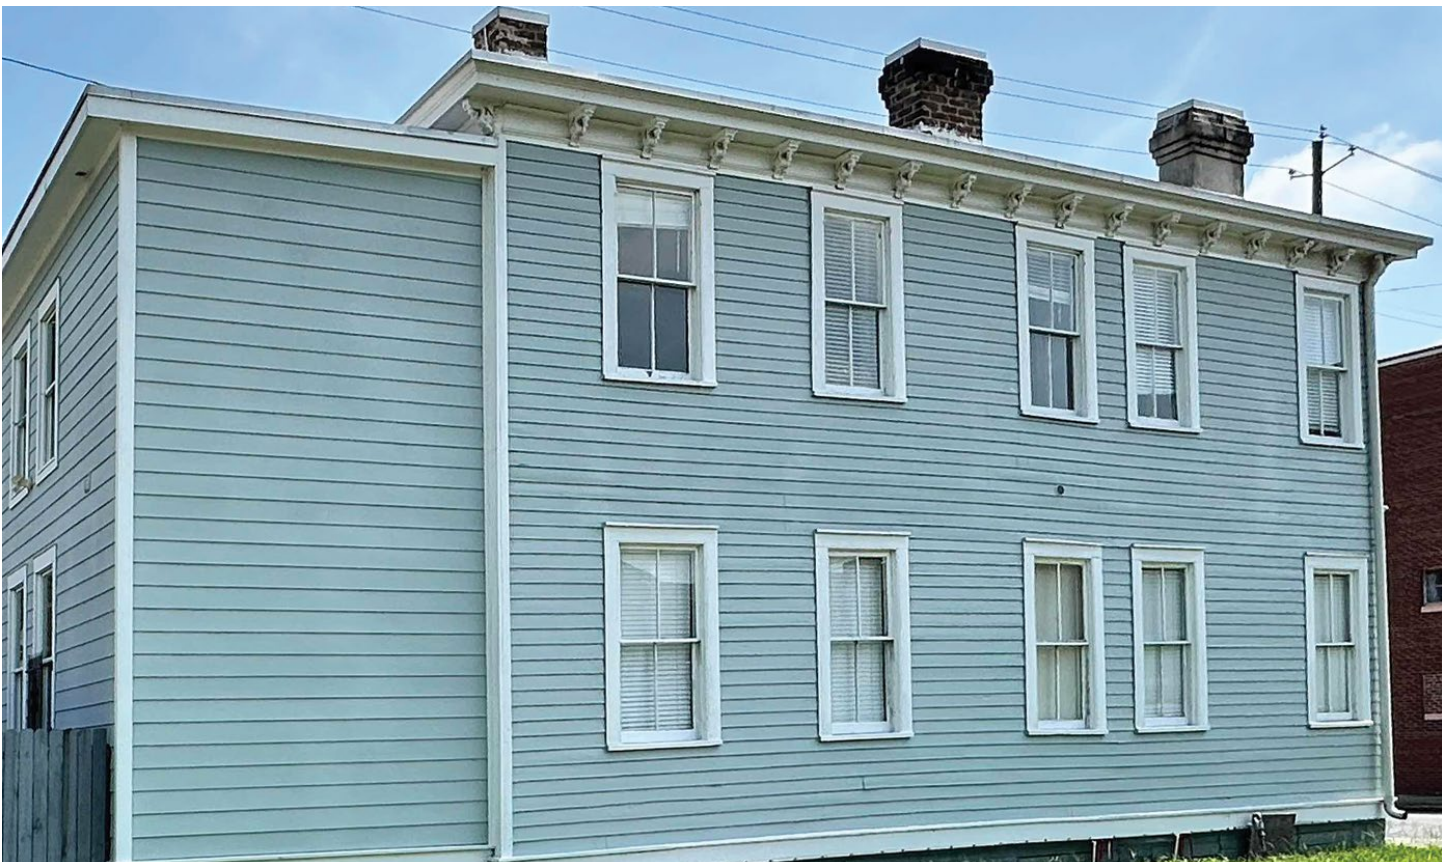
Figure 7. A new addition replaced non-historic construction on the rear elevation of this building. Fiber cement gives the addition a compatible appearance without replicating the exposure for thickness of the historic siding. Photo: Ward Architecture + Preservation.

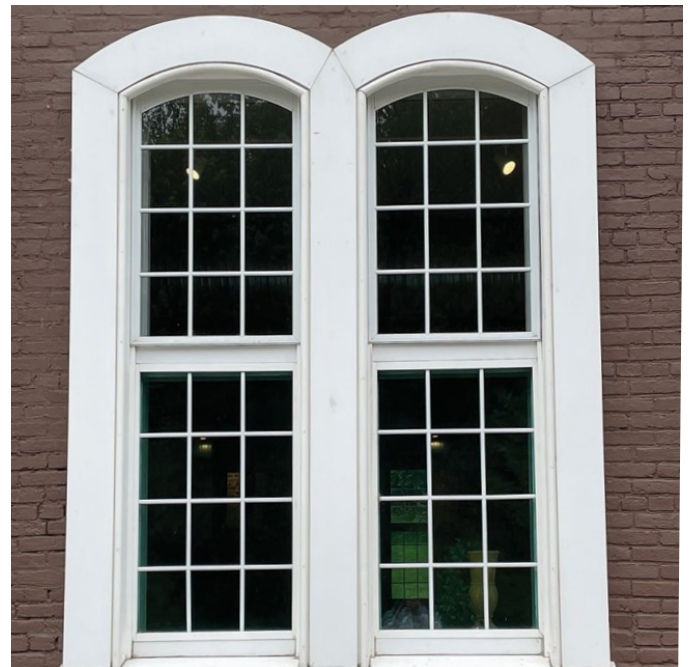
Figure 9. Previously bricked-in openings below the flood line were reopened and new aluminum windows installed with cellular PVC trim detailed to hold back moderate flood waters and survive exposure to water. Photo: John Sandor, NPS.

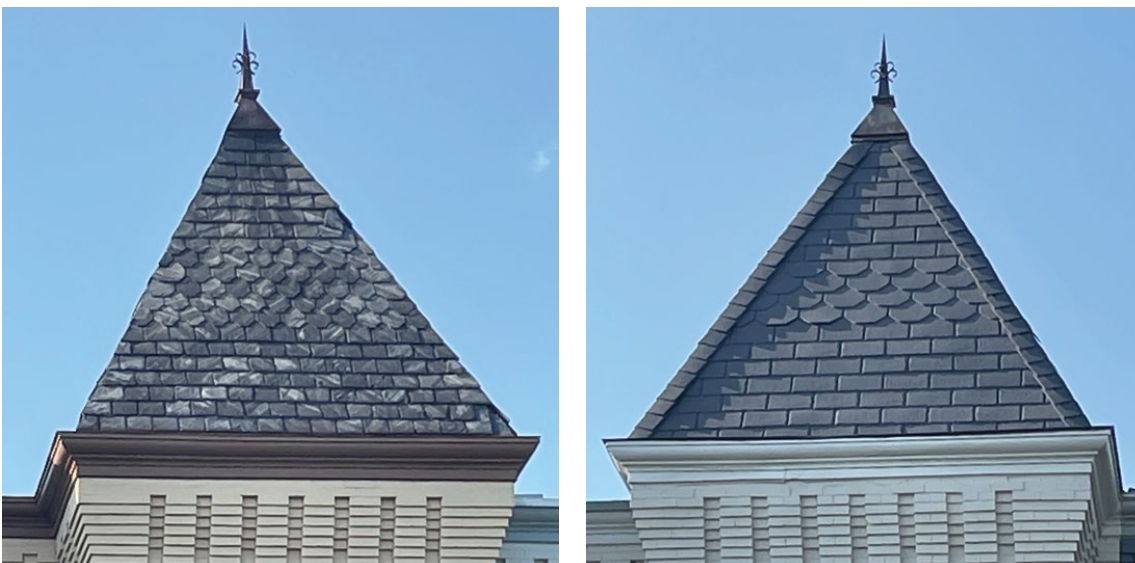
Figure 10. Polymer slates offer a choice of shapes but not sizes, limiting their ability to achieve a good visual match for some historic slate. With the size of the polymer slates (right) being nearly twice that of the historic slates (left), the scale of the entire feature is incompatibly altered. The molded edges of this material, which contribute to its ability to replicate slate, would be lost if each shingle was resized by cutting. Photo: John Sandor, NPS.

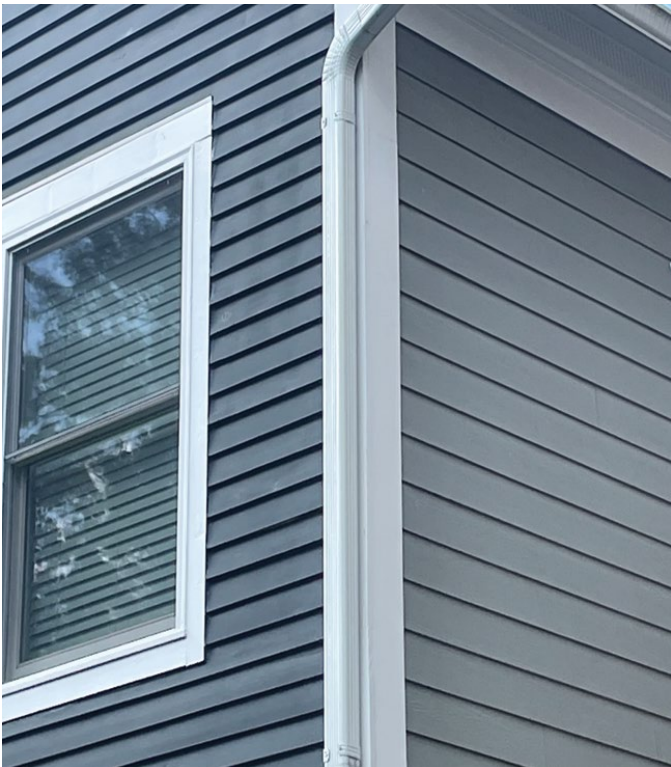
Figure 11. The thickness of the wood siding on the front (left) creates a deeper shadow line than is achieved with the fiber cement siding used on the side (right) elevation. While the exposure can be adjusted, fiber cement siding is not available in a matching thickness. Photo: John Sandor, NPS.

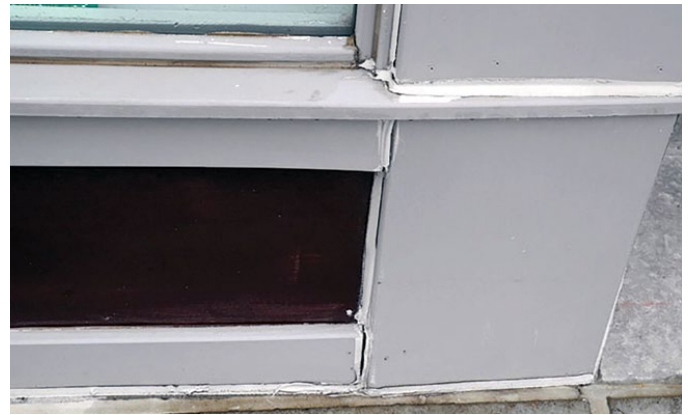
Figure 12. Cellulose composite materials, like wood, expand and contract with moisture. Here it was used to reconstruct a missing storefront. Unlike solid wood that is dimensionally stable parallel to the grain, this composite moves equally in all dimensions, resulting in gaps that were not adequately anticipated in the design. Photo: John Sandor, NPS.

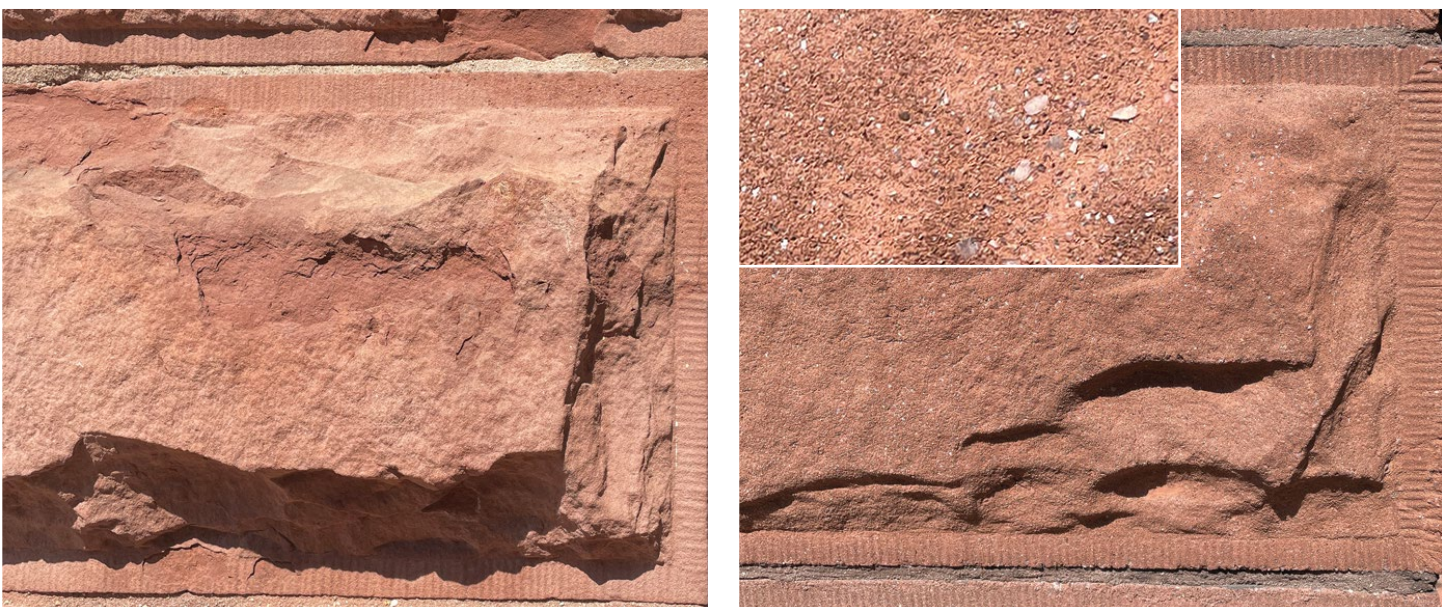
Figure 13. Cast stone was used to effectively replace individual blocks of sandstone. Both the original (left) and the substitute material (right) retain similar physical and visible properties. Having weathered for over 30 years, some erosion of the binder has revealed quartz grains of the aggregate (inset), but it is only noticeable upon close inspection. Photo: John Sandor, NPS.
