**Guidelines
for
Rehabilitation
and New
Construction
for**

**Fort Smith
Arkansas**

BELLE GROVE HISTORIC DISTRICT

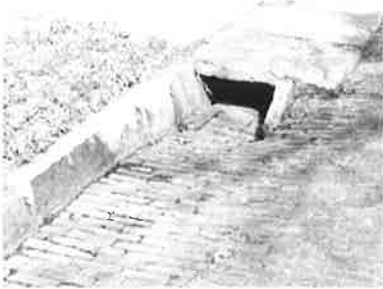
Some of the curbs are made of cut stone sections. Sidewalks are located on all of the streets. They are separated from the streets by a grass median. The lots in the District are as originally platted and typically are 50 ft. x 140 ft.

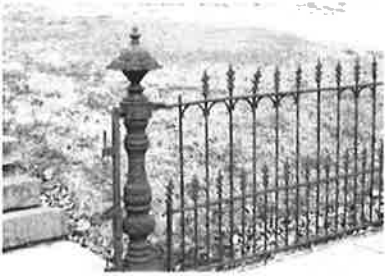
Numerous patterns and styles and several different materials of fencing are in the Belle Grove Historic District. These should be preserved and retained.

The materials used for the fences are wood and metal. Some of the metal fences are constructed above low stone or brick walls. Some of the fences have very decorative patterns, corner posts and gates. Fences and walls have served as security barriers and property line markers and to keep pets or children at home. Low stone or brick walls have been used as retaining walls at some locations.

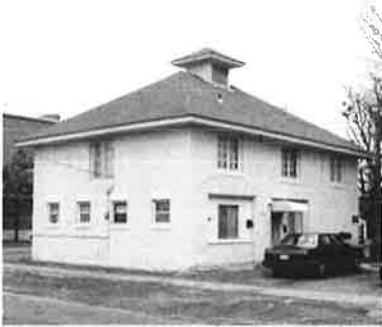
Within the Belle Grove Historic District there are several historic garages or carriage houses. Generally, they were constructed of the same materials and the same style as the main house. Since the alley was the prominent access to these structures, they were constructed at the alley property line. Some homes on corner lots have the garages opening onto the side street. Guests could be dropped off at the front walk and the automobile or carriage would be taken to the carriage house or garage. Most residents, who had automobiles then, like today, would put their automobile in the garage and enter their house from the back door.

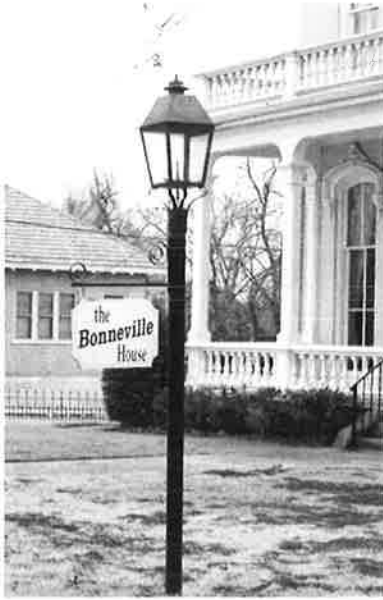
Lighting fixtures have evolved over the years since the invention of the electric light bulb. The gas lanterns of the earlier historic district were replaced with electric street lamps. The current street lamps resemble the early gas lamps.

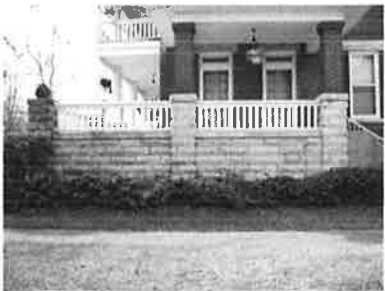
Painting Masonry can cause problems in the future. It conceals cracks, deteriorated mortar joints, and does not allow the masonry to "breathe" out any moisture that it may have absorbed. Once painted, masonry must continually be cleaned and repainted, sometimes at great expense.

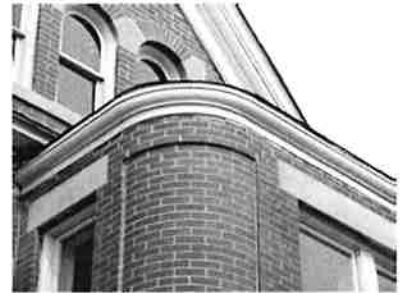
Repointing Masonry: After cleaning, repointing, repairs or replacing loose or missing mortar and masonry may be required. Before repointing begins, an experienced historic mason should have a laboratory analyze the content, texture, and color of the existing mortar. Materials and techniques have changed much over time and newer products are not compatible with the historic materials. Old mortar joints should be raked out with hand tools no less than 2 1/2 times the joint width. The joints must be thoroughly cleaned prior to pointing in new mortar. A good mortar mix will match the old one in sand type, lime content, texture, and color.

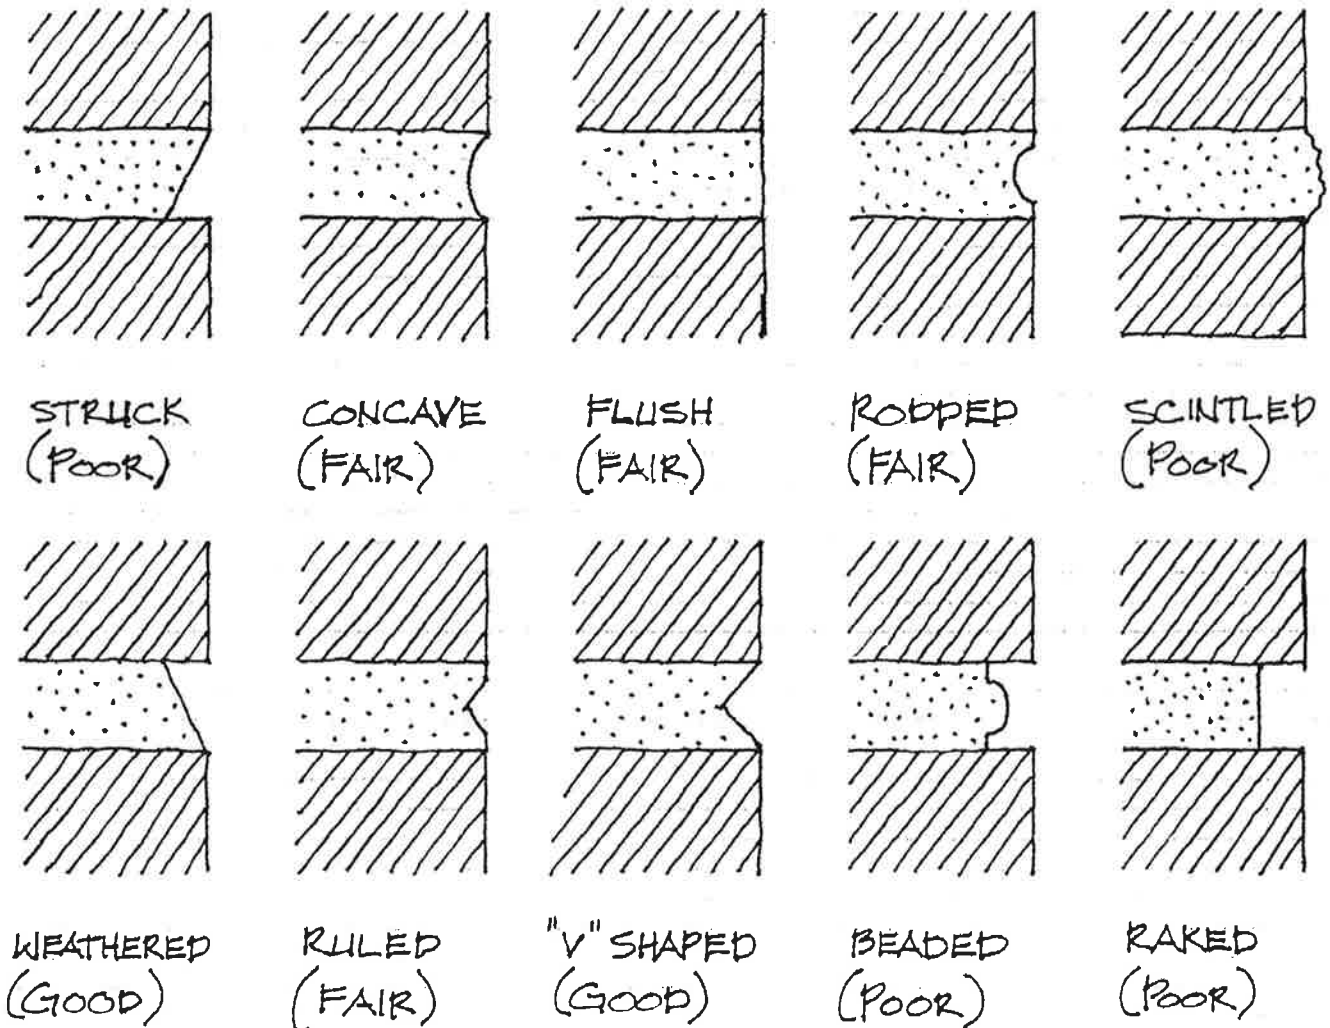
Masonry Sealing: Applying a masonry sealer is not a cure-all for masonry deficiencies. An application with a sealer can cause the masonry to not allow moisture out of the masonry. If it were applied during humid or damp weather, the existing moisture would be trapped. Sealers may also change the appearance of the masonry.

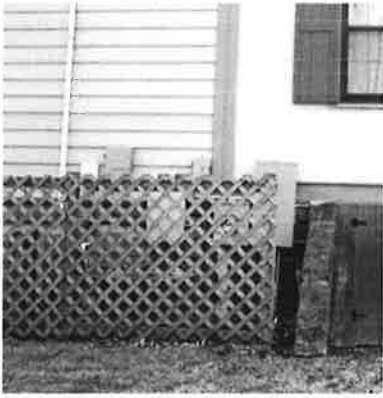
A. Air Conditioning

If replacement of HVAC equipment is necessary, if adding air conditioning to the historic building or if designing new construction, consider the use of a geothermal system. Not only is geothermal an energy saver, but it also allows for removing existing ground mounted condensing units which are not historic. Thus, there will be no equipment imposed on the building facade.
